THE ESPLANADE AND BELL STREET TRAFFIC AND PEDESTRIAN STRATEGY
THE ESPLANADE AND BELL STREET, TORQUAY
22 JUNE 2017

CLIENT: Surf Coast Shire Council

EXISTING CONDITIONS ROAD SAFETY AUDIT

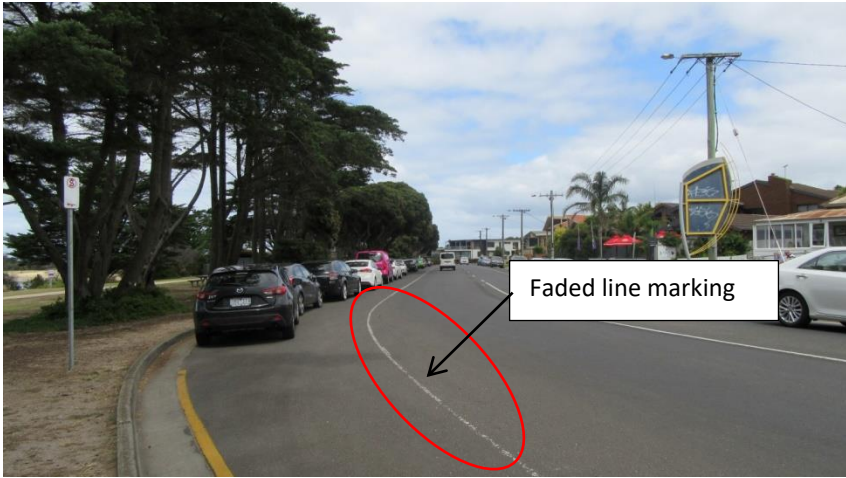
<p>Photo 2. Line marking on The Esplanade</p>

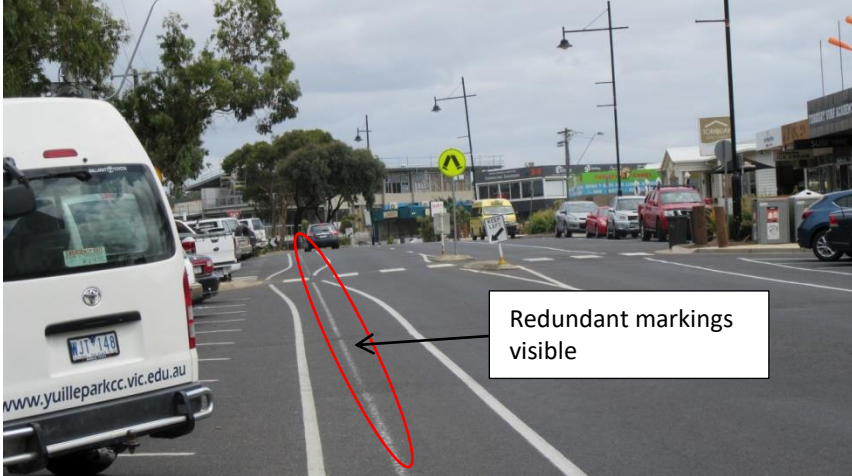
Issue No.	Review Findings & Recommendations	Risk	CLIENT RESPONSE	
			Accept: Yes / No	Reasons / Comments
	<p>At the zebra crossing near Price Street, pavement repair work has been undertaken near the refuge island and the zebra crossing marking has not been re-marked (see Photo 3). This may reduce conspicuity of the crossing for motorists.</p>   <p>Photo 3. Zebra crossing on The Esplanade near Price Street Redundant lane lines are also visible on Bell Street (See Photo 4).</p>

<p>Photo 4. Redundant lane markings on Bell Street</p> <p>Recommendation 2: Remove redundant line marking on The Esplanade and Bell Street.</p> <p>Recommendation 3: Re-mark faded line marking on The Esplanade.</p> <p>Recommendation 4: Re-mark missing marking at the zebra crossing on The Esplanade at Price Street.</p>			
3	<p>Bicycle lanes on The Esplanade</p> <p>Bicycle lanes are provided along both sides of The Esplanade however the bicycle logos are typically very faded or non-existent and no 'Bicycle Lane' signage is provided. This reduces the conspicuity of the bicycle lanes to motorists and other road users.</p> <p>Currently the bicycle lanes end approaching the Price Street and Bell Street intersections (although this is not indicated by signage or pavement markings) (see Photo 5). Consideration should be given to bicycle treatments at these intersections.</p>	Medium

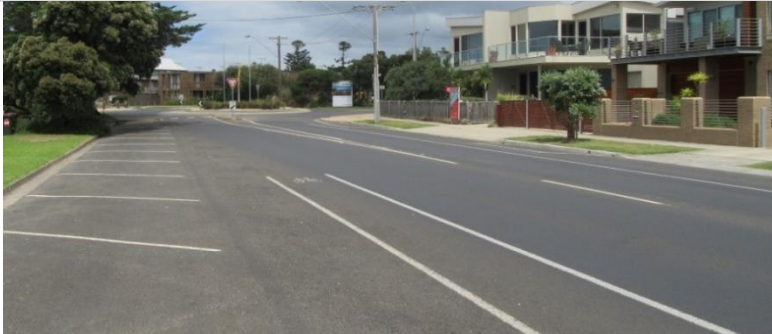
<p>Photo 5. End of bicycle lane on The Esplanade approaching Bell Street</p> <p>Desirably the bicycle lanes should continue through the Price Street intersection, although this may require relocation of the bus stops and changes to the kerb outstand. At the roundabout at Bell Street, sharrows could be provided on each approach to the roundabout to indicate to all road users that cyclists are to share the traffic lane.</p> <p>The bicycle lane lines on the western side of The Esplanade at Gilbert Street are confusing as the redundant lines have not been removed (see Photo 6).</p>

Issue No.	Review Findings & Recommendations	Risk	CLIENT RESPONSE	
			Accept: Yes / No	Reasons / Comments
	<p>Recommendation 5: Mark/remark bicycle logos on The Esplanade at 200m intervals in accordance with AS 1742.9-2000.</p> <p>Recommendation 7: Provide bicycle lane signage in accordance with AS 1742.9 – 2000, including End Bicycle Lane signage where bicycle lanes end.</p> <p>Recommendation 8: Continue bicycle lane on The Esplanade through the Price Street intersection.</p> <p>Recommendation 9: Provide sharrows on each approach to the roundabout at The Esplanade/Bell Street intersection.</p> <p>Recommendation 10: Remove redundant lines on the western side of The Esplanade, north of Gilbert Street.</p>			
4	<p>Bicycle lane widths on The Esplanade</p> <p>Where The Esplanade bends (at Anderson Street and south of Gilbert Street), the bicycle lane on the inside of the curves narrow to less than 1.5m, which is less than the desirable width for an on-road bicycle lane.</p> <p>Recommendation 11: Review lane lines on The Esplanade around the bends at Anderson Street and south of Gilbert Street and increase the width of the bicycle lanes to minimum 1.5m.</p>	Medium

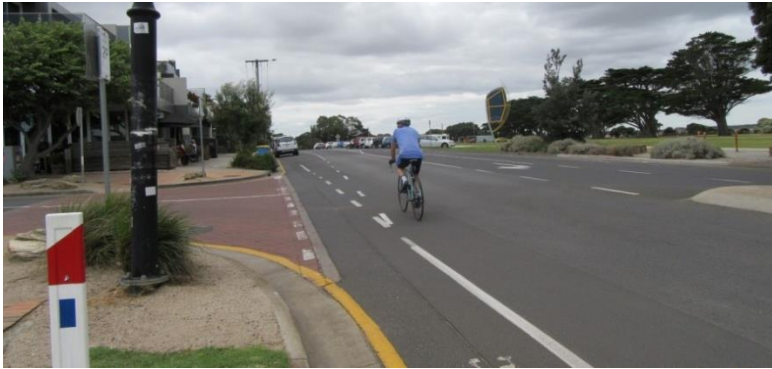
<p>Photo 6. Redundant bicycle lane markings on The Esplanade at Gilbert Street</p>

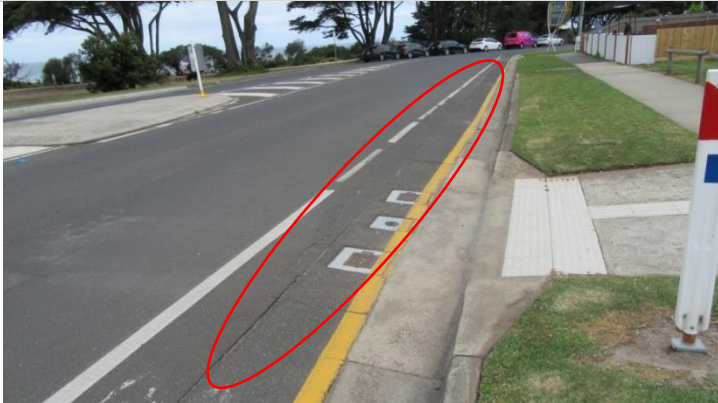
6	<p>Pavement condition on The Esplanade</p> <p>On the western side of The Esplanade, there is a crack in the road pavement near the kerb which provides a poor riding surface for cyclists. At several locations pits are also located in the road pavement within the bike lane (see Photos 7 and 8). The uneven surface also coincides with the pedestrian crossing point south of Gilbert Street.</p>	Low

<p>Photo 7. Poor surface condition on the western side of The Esplanade south of Gilbert Street.</p>

<p>Photo 8. Poor surface condition on the western side of The Esplanade south of Zeally Bay Road.</p> <p>Recommendation 16: <i>Repair road pavement on the western side of the Esplanade to provide an even surface. Make surface flush around pits.</i></p>

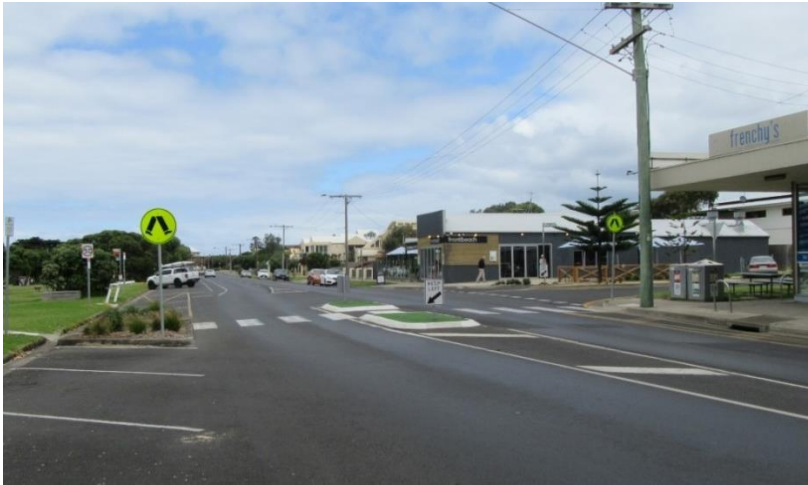
Issue No.	Review Findings & Recommendations	Risk	CLIENT RESPONSE	
			Accept: Yes / No	Reasons / Comments
7	<p>Zebra Crossing on The Esplanade north of Price Street</p> <p>At the zebra crossing on The Esplanade north of Price Street, no pedestrian crossing signs are provided on the refuge island (see Photo 9). Provision of pedestrian crossing signs on the refuge island, facing each direction, would increase conspicuity of the crossing to approaching road users. There may be a benefit to traffic flow also, as motorists would only be required to give way to pedestrians on the crossing between the kerb and the refuge island (currently motorists must give way to pedestrians on the crossing on either side of the refuge island).</p>

<p>Photo 9. Zebra Crossing on The Esplanade north of Price Street</p> <p>Recommendation 17: Provide Pedestrian Crossing signs on the refuge island, facing each direction, at the zebra crossing on The Esplanade north of Price Street.</p>	Low

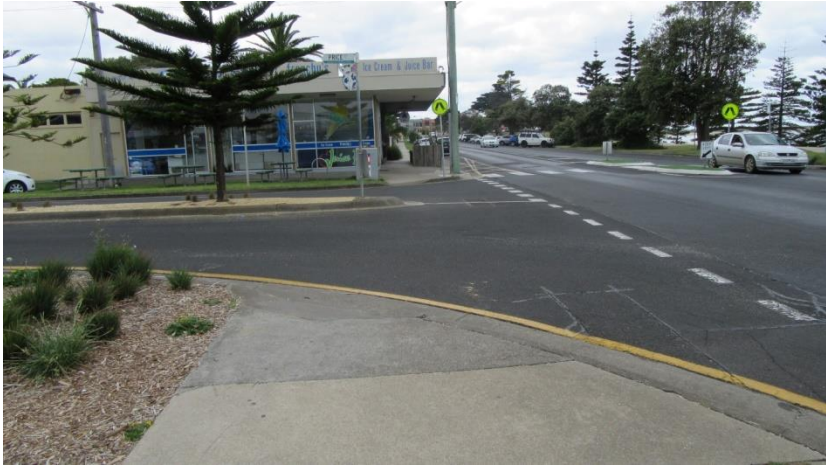
Issue No.	Review Findings & Recommendations	Risk	CLIENT RESPONSE	
			Accept: Yes / No	Reasons / Comments
	<p>for pedestrians crossing the street (see Photo 10). The kerb ramps on either side of Price Street direct pedestrians to walk around the front of the splitter island. Desirably the splitter island would include kerb ramps which align with the footpath along The Esplanade, and would provide a refuge for pedestrians crossing the street.</p>

<p>Photo 10. Splitter island on Price Street at The Esplanade</p> <p>Recommendation 18: Review design of the splitter island in Price Street at The Esplanade with a view to providing kerb ramps and a refuge for pedestrians crossing the street. Realign footpath kerb ramps on either side of Price Street to align with splitter/refuge island as necessary.</p>			
9	<p>Splitter island in Pride Street at Bell Street</p> <p>The splitter island in Pride Street at Bell Street has no kerb ramps making it difficult for mobility impaired pedestrians to cross (see Photo 11).</p>	Low

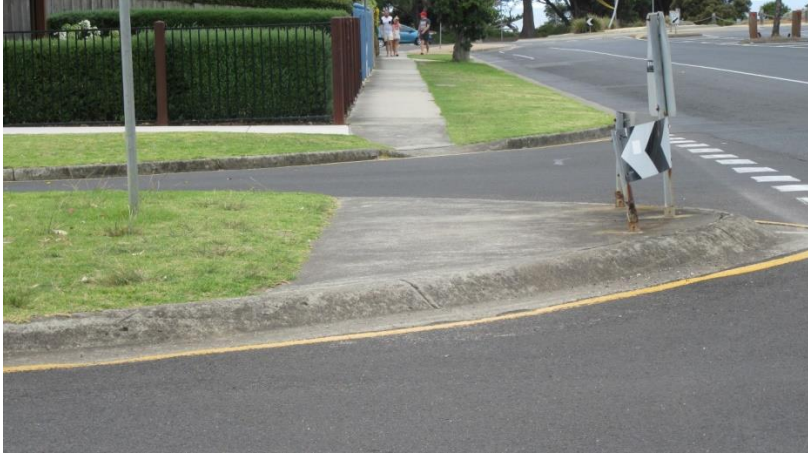
<p>Photo 11. Splitter island on Pride Street at Bell Street</p> <p>Recommendation 19: Provide kerb ramps on splitter island in Pride Street at Bell Street. Align kerb ramps on the eastern and western side of Pride Street to align with kerb ramps on the splitter island.</p>			
10	<p>Provision for pedestrians crossing at The Esplanade/Bell Street roundabout</p> <p><i>Pedestrians Give Way</i> signs are provided on both sides of Bell Street at The Esplanade roundabout (see Photo 12). The signs are mounted above head height and are likely to be unnoticed by many pedestrians. It may be more effective to provide signage on a lower totem style pole or use pavement markings.</p> <p>Alternatively, consideration could be given to providing priority for pedestrians crossing at the intersection. Zebra crossings could be provided on each leg of the roundabout, set back approximately 6m from the circulating lane.</p>	Low

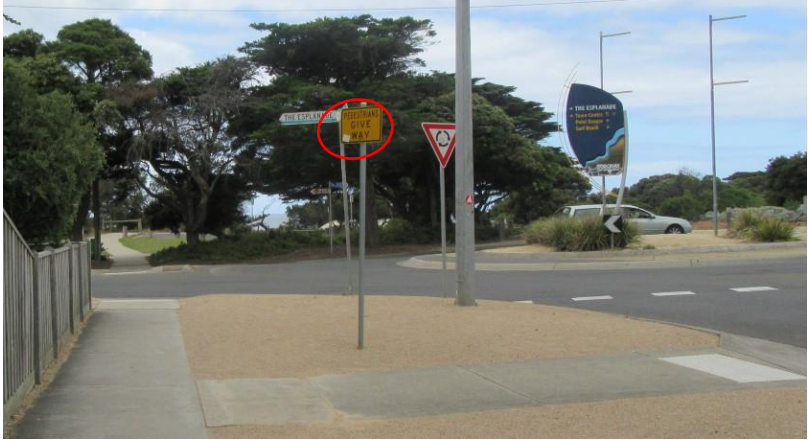
<p>Photo 12. Pedestrians Give Way sign at The Esplanade/Bell Street roundabout</p> <p>Recommendation 20: Replace Pedestrians Give Way sign with signage on a totem style pole or pavement markings on Bell Street at The Esplanade.</p> <p>Recommendation 21: Consider provision of zebra crossings on each leg of The Esplanade/Bell Street roundabout.</p>			
11	<p>Walkway on the north-eastern corner of The Esplanade/Bell Street roundabout</p> <p>The timber walkway on the north-eastern corner of The Esplanade/Bell Street roundabout is damaged and could be a trip hazard (see Photo 13).</p>	Low

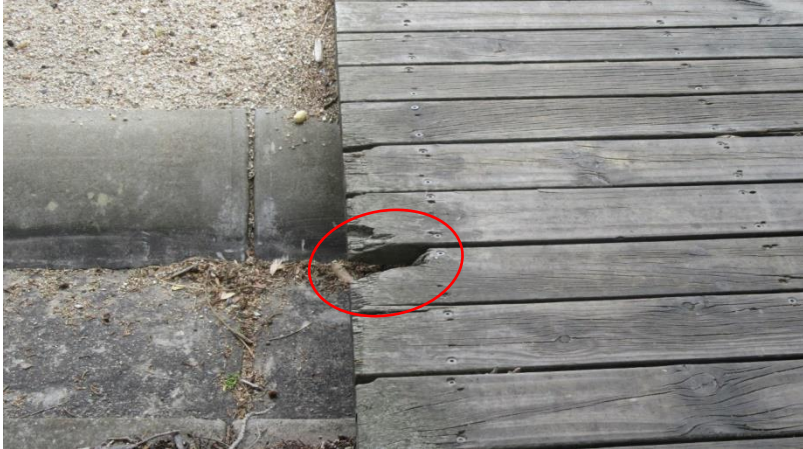
<p>Photo 13. Damaged timber walkway on the northern side of The Esplanade at Bell Street Recommendation 22: Repair timber walkway on the north-eastern side of The Esplanade/ Bell Street roundabout.</p>			
12	<p>Obstacles on footpath along Bell Street</p> <p>At several locations along Bell Street, clothing racks and sign boards are placed on the footpath and are obstacles for pedestrians (see Photos 14 and 15).</p>	Low

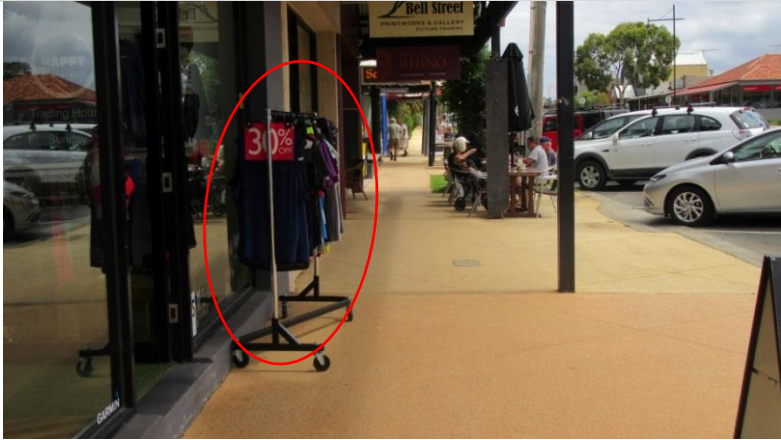
<p>Photo 14. Clothing rack on footpath, southern side of Bell Street</p>

<p>Photo 15. A-frame sign board on footpath, southern side of Bell Street</p> <p>Recommendation 23: <i>Ensure goods/signs place on footpath are in accordance with Councils Local Laws.</i></p>

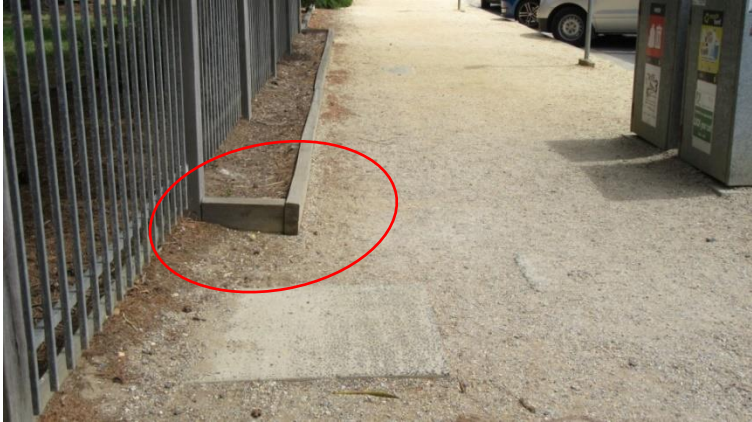
Issue No.	Review Findings & Recommendations	Risk	CLIENT RESPONSE	
			Accept: Yes / No	Reasons / Comments
13	<p>Garden strip adjacent to caravan park on southern side of Bell Street,</p> <p>Adjacent to the caravan park, on the southern side of Bell Street, the timber garden edge juts in and out from the fence line and is a potential trip hazard for pedestrians on the footpath (see Photo 16).</p>

<p>Photo 16. Timber garden strip adjacent to caravan park juts in and out from the fenceline, southern side of Bell Street</p> <p>Recommendation 24: Redo timber garden edge adjacent to caravan park to provide a consistent edge parallel to the footpath, preferably within the fence line.</p>	Low		
14	<p>Step on footpath, northern side of Bell Street west of Munday Street</p> <p>On the northern side of Bell Street, west of Munday Street, a step is located outside the building on the footpath and is a potential trip hazard (see Photo 17). It is noted that the real estate agent places his advertising papers adjacent to the step during the day which may reduce the risk. Desirably the step would be removed, although this is unlikely to be feasible. Alternatively, pavement markings and/or reflective markings should be provided to increase conspicuity of the step.</p>	Medium

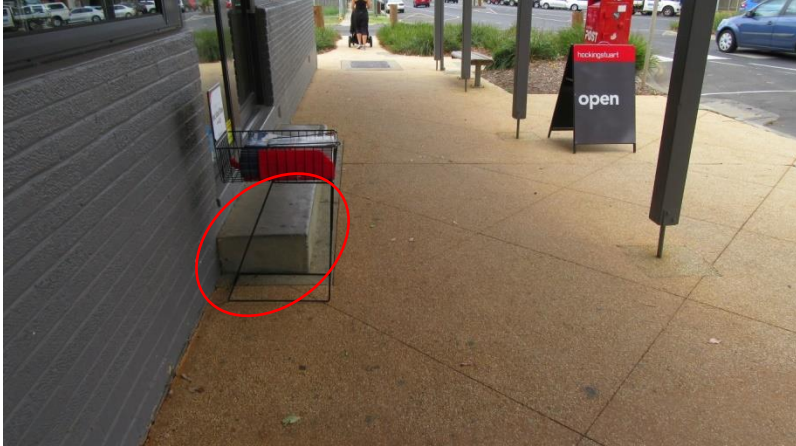
<p>Photo 17. Step on footpath, northern side of Bell Street west of Munday Street <i>Recommendation 25: Provide pavement markings on each approach to the step and/or reflective markers on each edge of the step to increase its conspicuity.</i></p>			
15	<p>Footpath condition, southern side of Bell Street between Davidson Drive and Surf Beach Drive</p> <p>The gravel footpath along the southern side of Bell Street between Davidson Drive and Surf Beach Drive is rutted and has pit lids jutting out (see Photo 18), providing a poor surface for pedestrians. In addition a utility pole is located in near the middle of the path and may be difficult to see in poor light conditions.</p>	Low

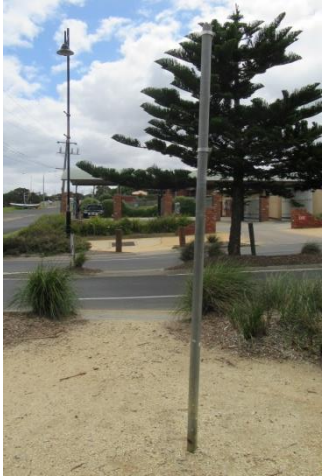
<p>Photo 19. Redundant sign post, southern side of Bell Street at Surf Beach Drive</p> <p>In addition, the kerb ramp on the northern side of the crossing does not align with the kerb ramps on the refuge island.</p> <p>Recommendation 28: Remove redundant signpost on south-eastern corner of Bell Street/ Surf Beach Drive, or replace sign and relocate closer to plants.</p> <p>Recommendation 29: Consider modifying kerb ramp on northern side of Bell Street, east of Surf Beach Drive, to align with kerb ramps on refuge island.</p>			
17	<p>Blind accesses, northern side of Bell Street</p> <p>Along the northern side of Bell Street, between Rudd Avenue and Munday Street, there are a couple of private properties with vehicular access to Bell Street that have no visibility to pedestrians approaching along the footpath (see Photo 20).</p>	Medium

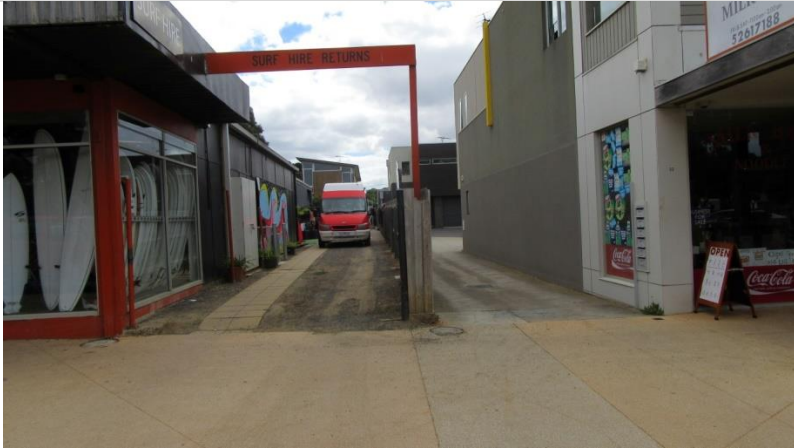
<p>Photo 20. Blind accesses along northern side of Bell Street</p> <p>Recommendation 30: Liaise with property owners to consider treatments to reduce potential for conflict between exiting vehicles and pedestrians, such as signage (eg. Look for Pedestrians) or speed humps in the driveway.</p>			
18	<p>Tactile Ground Surface Indicators (TGSIs)</p> <p>Where the footpath on the western side of The Esplanade crosses side streets, Tactile Ground Surface Indicators (TGSIs) are generally not provided. Similarly some crossing points along Bell Street don't have TGSIs. Where TGSIs are provided, there are often no directional indicators.</p> <p>At the bus stop on the western side of The Esplanade, north of Price Street, part of the directional indicator is missing (see Photo 21).</p>	Medium

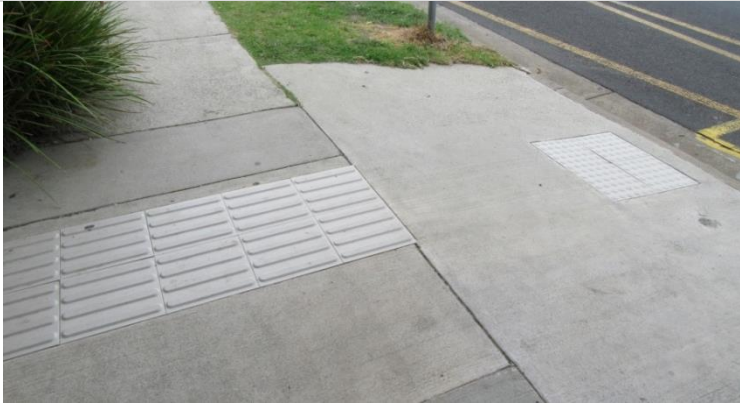
<p>Photo 21. Directional TGSIs partially missing at bus stop, western side of The Esplanade, north of Price Street</p> <p>Recommendation 31: Undertake a review of Tactile Ground Surface Indicators in the audit area and provide TGSIs as appropriate in accordance with Australian Standard AS1428.4.1:2009.</p>			
19	<p>Timber posts in median and at pedestrian crossing points in Bell Street</p> <p>At numerous locations along Bell Street, large timber bollards are located in median islands and at pedestrian crossing points (see, for example Photos 22 and 23). The timber bollards are a potential hazard if struck by an errant vehicle. The bollards in the median islands and on the departure side of the Bell Street/Davidson Street roundabout are particularly vulnerable to being struck.</p> <p>In addition, where the bollards are located at pedestrian crossing points, they can be a potential hazard to vision impaired pedestrians, particularly where they are located in the path of travel. See, for example, the bollard on the north eastern corner of Bell Street/Rudd Avenue intersection, as shown in Photo 22. (Note also, no TGSIs at this location).</p>	Medium

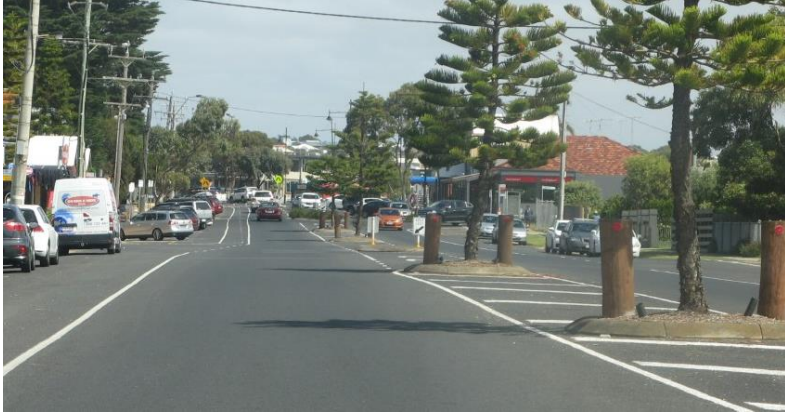
<p>Photo 22. Timber posts in median islands along Bell Street</p>

<p>Photo 23. Timber posts at pedestrian crossing point, north eastern corner of Bell Street/Rudd Avenue</p> <p>Recommendation 32: Remove timber bollards from the Bell Street median islands and provide reflectors on kerb.</p> <p>Recommendation 33: Remove timber bollards from the departure side of the Bell</p>

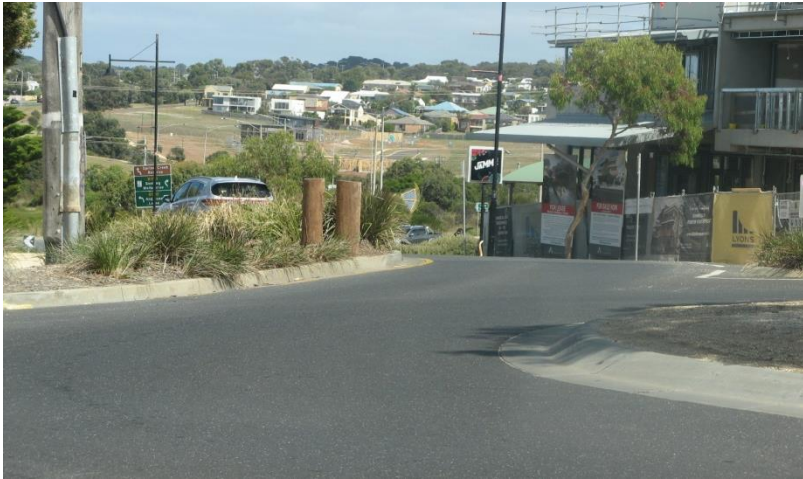
<p>Photo 24. Grasses planted on the south eastern corner of the Bell Street/Davidson Drive/Rudd Avenue roundabout</p>	Low

Issue No.	Review Findings & Recommendations	Risk	CLIENT RESPONSE	
			Accept: Yes / No	Reasons / Comments
	  <p>Photo 25. Grasses planted in the median island at zebra crossing on Bell Street west of Munday Street</p> <p><i>Recommendation 35: Trim/maintain grasses adjacent to carriageway to ensure good sightlines and visibility of pedestrian crossings/signs/traffic islands.</i></p>			
21	<p>Cracked/damaged footpath</p> <p>At numerous locations, cracks/damage to the footpath and recessed/protruding pit lids were observed, which are potential tripping hazards (see, for example, Photos 26 to 28).</p>	Medium

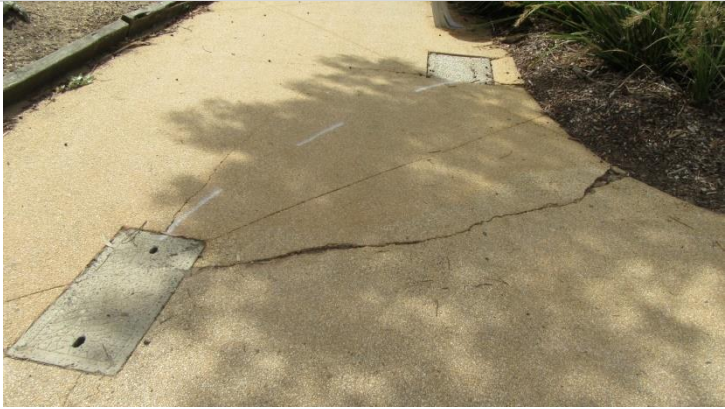
<p>Photo 26. Cracked footpath on northern side of Bell Street, adjacent to No. 38-40</p>

<p>Photo 30. Drop off adjacent to footpath and broken driveway at No 25 The Esplanade</p> <p>Recommendation 36: <i>Ensure the Shire’s footpath maintenance program continues to repair footpaths, including the above locations. Areas adjacent to footpaths should also be maintained to reduce potential trip hazards.</i></p>			
22	<p>The Esplanade footpath crossing at Gilbert Street</p> <p>Where the footpath on the western side of The Esplanade approaches Gilbert Street, from both north and south, the concrete path terminates at a brick paved path in a staggered T-layout (see Photos 31 and 32). There are several potential trip hazards in this area with differences in levels between the concrete path, brick paving, adjacent gravel area and pit lids. Rocks located close to the path are also potential trip hazards.</p>	Low

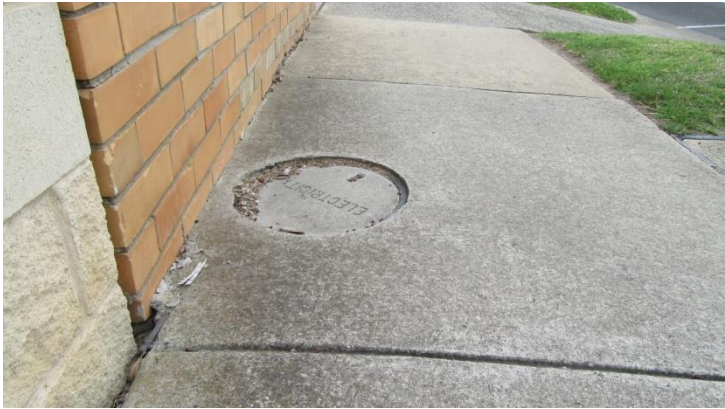
<p>Photo 27. Recessed pit lid on western side of The Esplanade, adjacent to No. 14A</p>

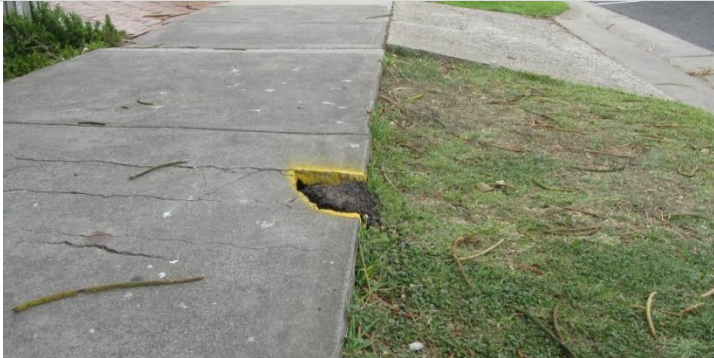
<p>Photo 28. Broken footpath on western side of The Esplanade, adjacent to No. 24</p> <p>At other locations, potential trip hazards were observed adjacent to the footpath (see, for example Photos 29 and 30).</p>

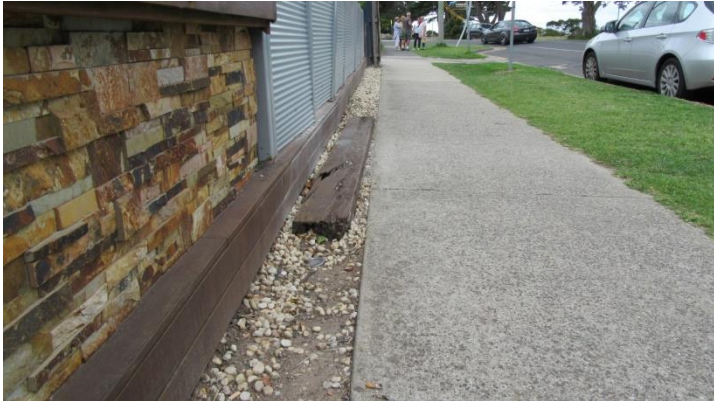
<p>Photo 29. Timber adjacent to the footpath is a potential trip hazard, western side of The Esplanade, adjacent to Zeally's Bar and Grill</p>

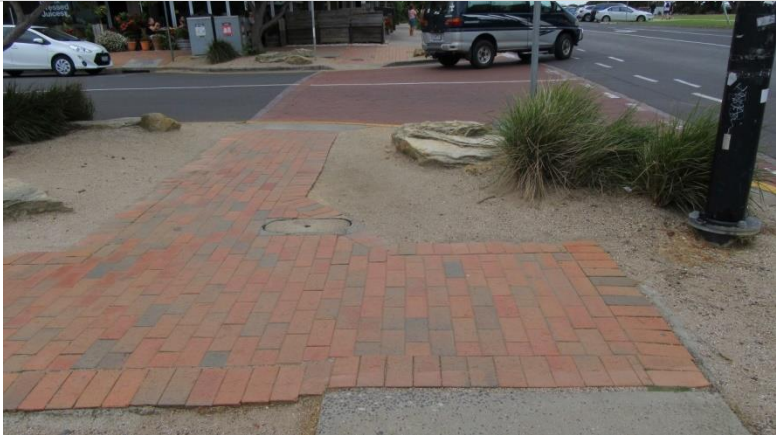
<p>Photo 31. Footpath on the western side of The Esplanade approaching Gilbert Street, facing north</p>

Issue No.	Review Findings & Recommendations	Risk	CLIENT RESPONSE	
			Accept: Yes / No	Reasons / Comments
	Recommendation 37: Provide smooth transition between concrete, brick and gravel surfaces. Ensure pit lids are even with surrounding surface. Remove rocks or relocate further from pedestrian path of travel.			
23	<p>Broken post and rail fence on the western side of The Esplanade south of Gilbert Street</p> <p>The post and rail fence on the western side of The Esplanade, south of Gilbert Street, is broken and potential hazardous (see Photo 33). The rail is lying on the ground, partially on the footpath, and the bolt on the post is exposed and sticking out.</p>

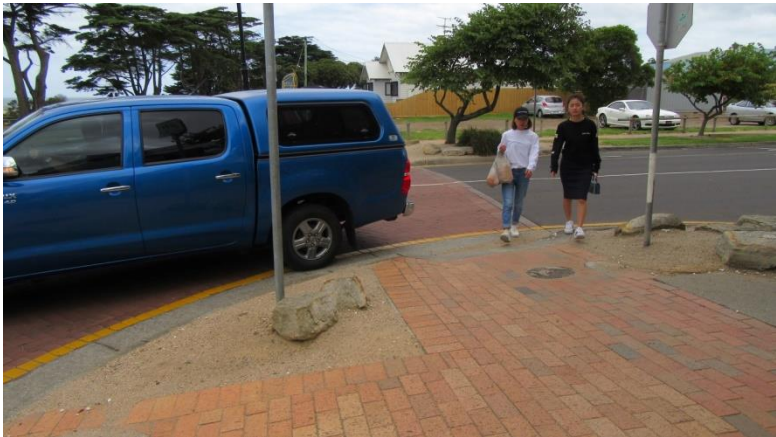
<p>Photo 32. Footpath on the western side of The Esplanade approaching Gilbert Street, facing south</p>

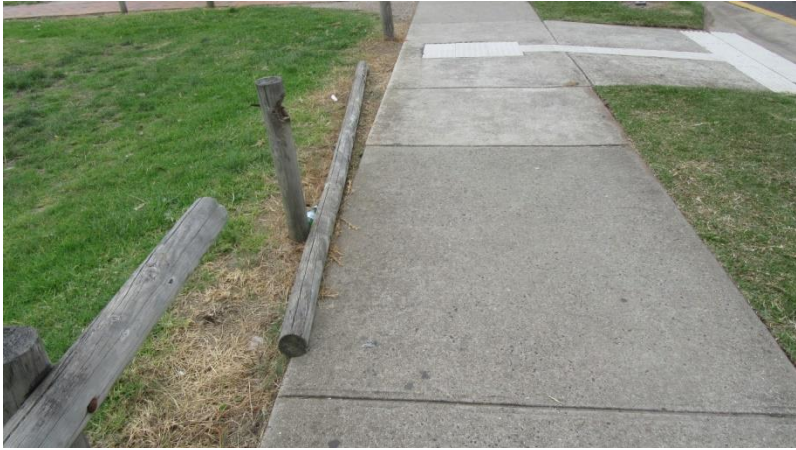
<p>Photo 33. Broken post and rail fence on the western side of The Esplanade, south of Gilbert Street</p> <p>Recommendation 38: Repair broken post and rail fence on the western side of The Esplanade south of Gilbert Street, or remove.</p>	Medium

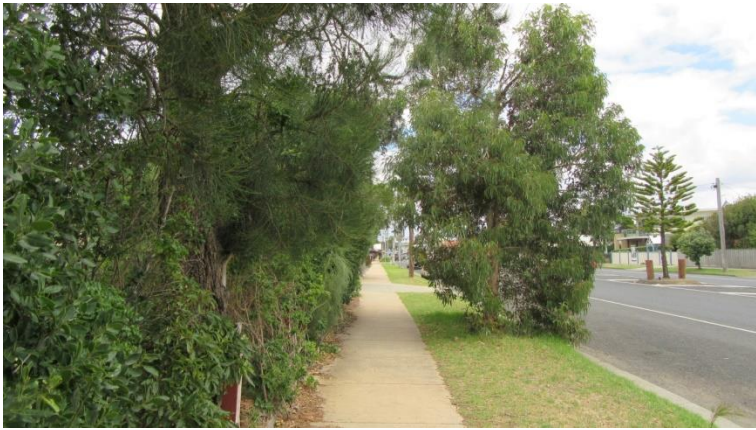
Issue No.	Review Findings & Recommendations	Risk	CLIENT RESPONSE	
			Accept: Yes / No	Reasons / Comments
	<p>width of the footpath, can be potentially hazardous (particularly at eye height) and may reduce visibility for cars exiting from driveways (see, for example, Photos 29 to 31).</p>

<p>Photo 34. Overhanging vegetation, southern side of Bell Street, west of The Esplanade</p>

<p>Photo 36. Overhanging vegetation at 18 The Esplanade</p> <p>Recommendation 39: <i>Contact property owners to ensure that overhanging vegetation is trimmed or removed.</i></p>

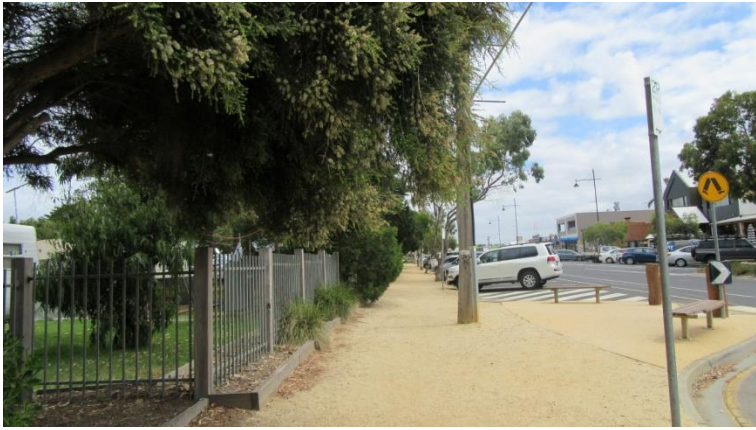
<p>Photo 35. Overhanging vegetation, southern side of Bell Street adjacent to caravan park</p>
